Supplementary Report

PAP/2017/0660 – The Cuckoo’s Rest, Dordon and PAP/2017/0659 – New Street, Dordon

Structural Inspection Report

Structural Inspection Report
of The Cuckoos Rest Pub
Dordon

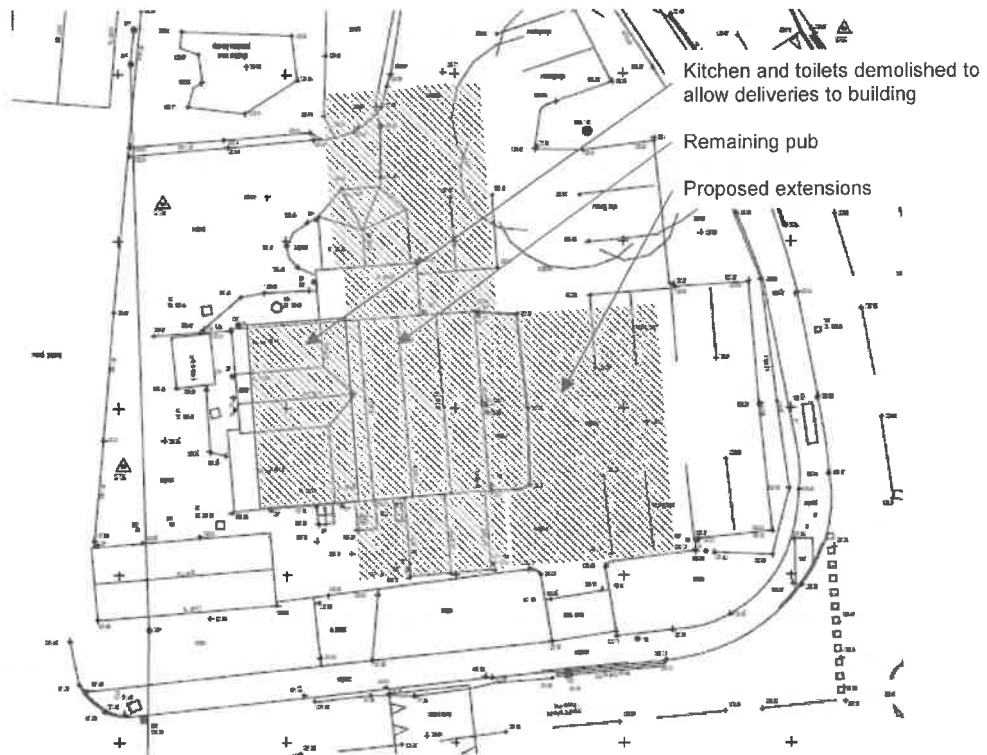
- 8.0 The floor area of the existing building once the toilets and kitchen (shown in blue) are removed is 126m². The shop floor of the new building is proposed be 426m² which excludes unit B. As such, the existing building would need to be considerably extended (shown in red) which would require an extension towards Whitehouse Road. This would cover part of the front elevation of the existing pub and drastically alter the aesthetics of the existing building.
