Project: LAND TO THE EAST OF THE FORMER TAMWORTH GOLF COURSE, TAMWORTH

Title: ROBEY'S LANE ACCESS NO. 3B PRELIMINARY LAYOUT

STAGE 1 ROAD SAFETY AUDIT

Road Safety Audit Response Report

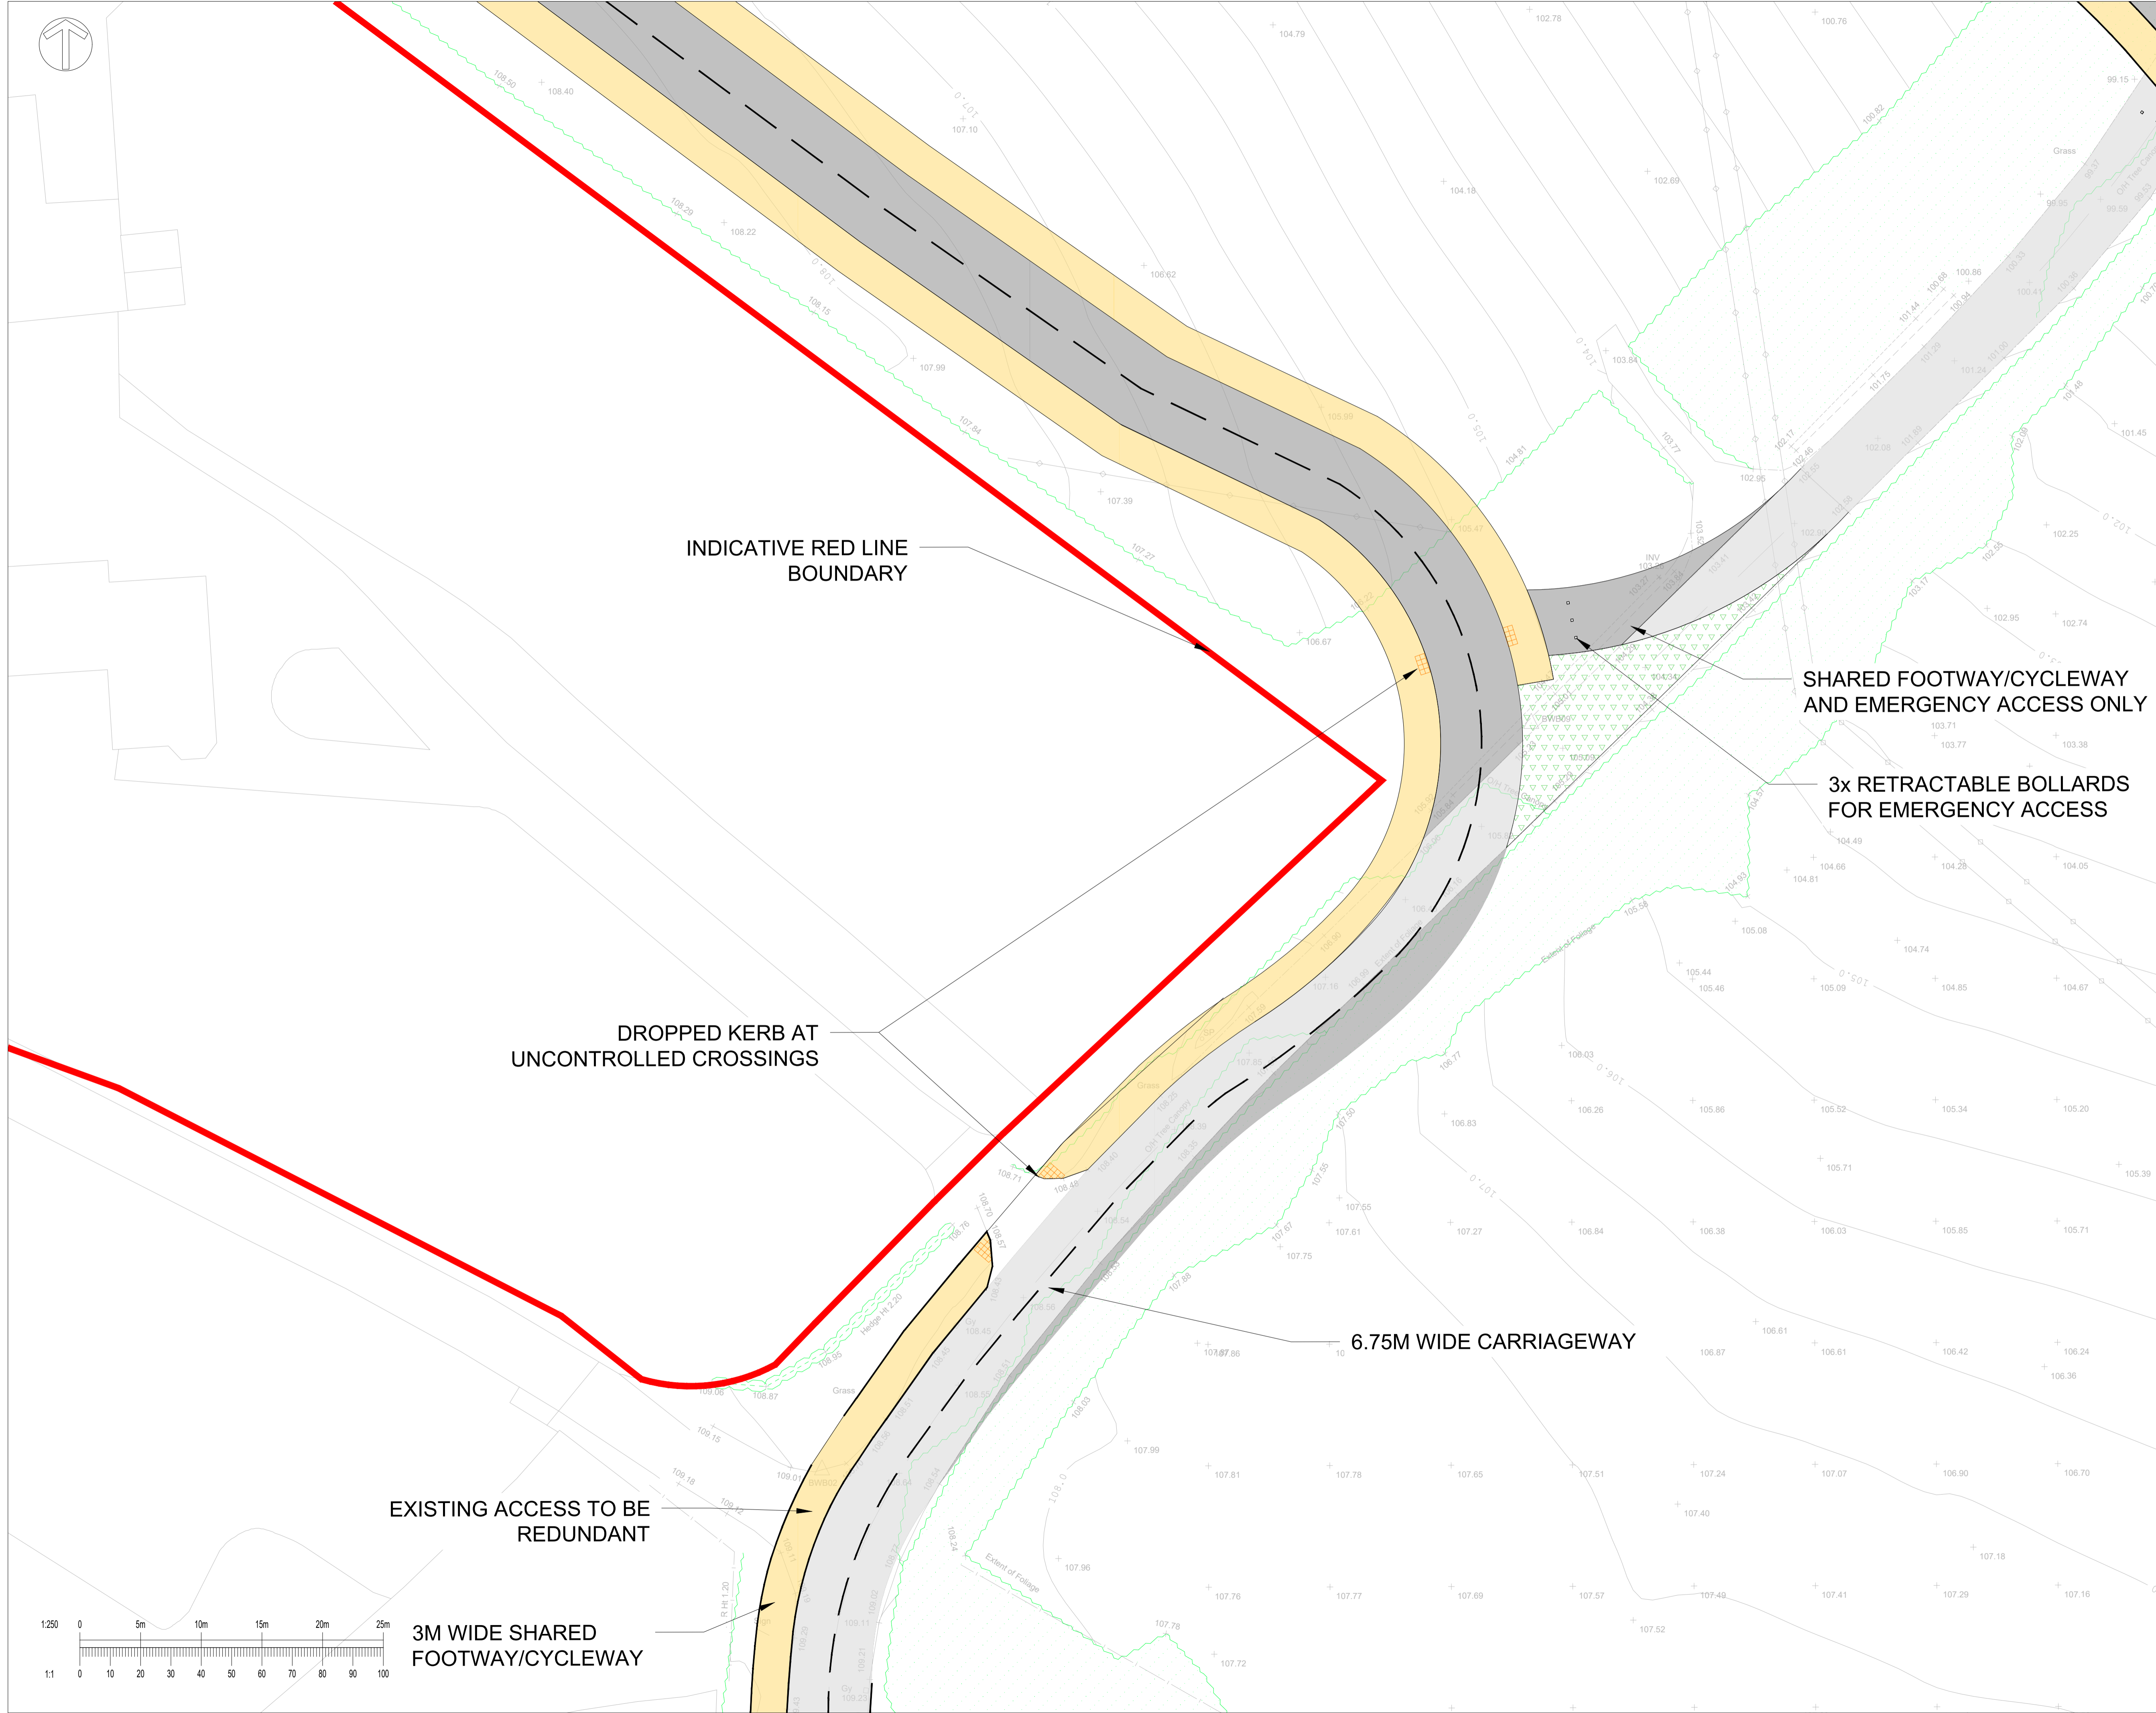
Title
ROBEY'S LANE ACCESS NO. 3A PRELIMINARY LAYOUT

3M WIDE SHARED FOOTWAY/CYCLEWAY

INDICATIVE RED LINE BOUNDARY

DROPPED KERB AT UNCONTROLLED CROSSINGS

EXISTING ACCESS TO BE REDUNDANT

6.75M WIDE CARRIAGEWAY

SHARED FOOTWAY/CYCLEWAY AND EMERGENCY ACCESS ONLY

3x RETRACTABLE BOLLARDS FOR EMERGENCY ACCESS

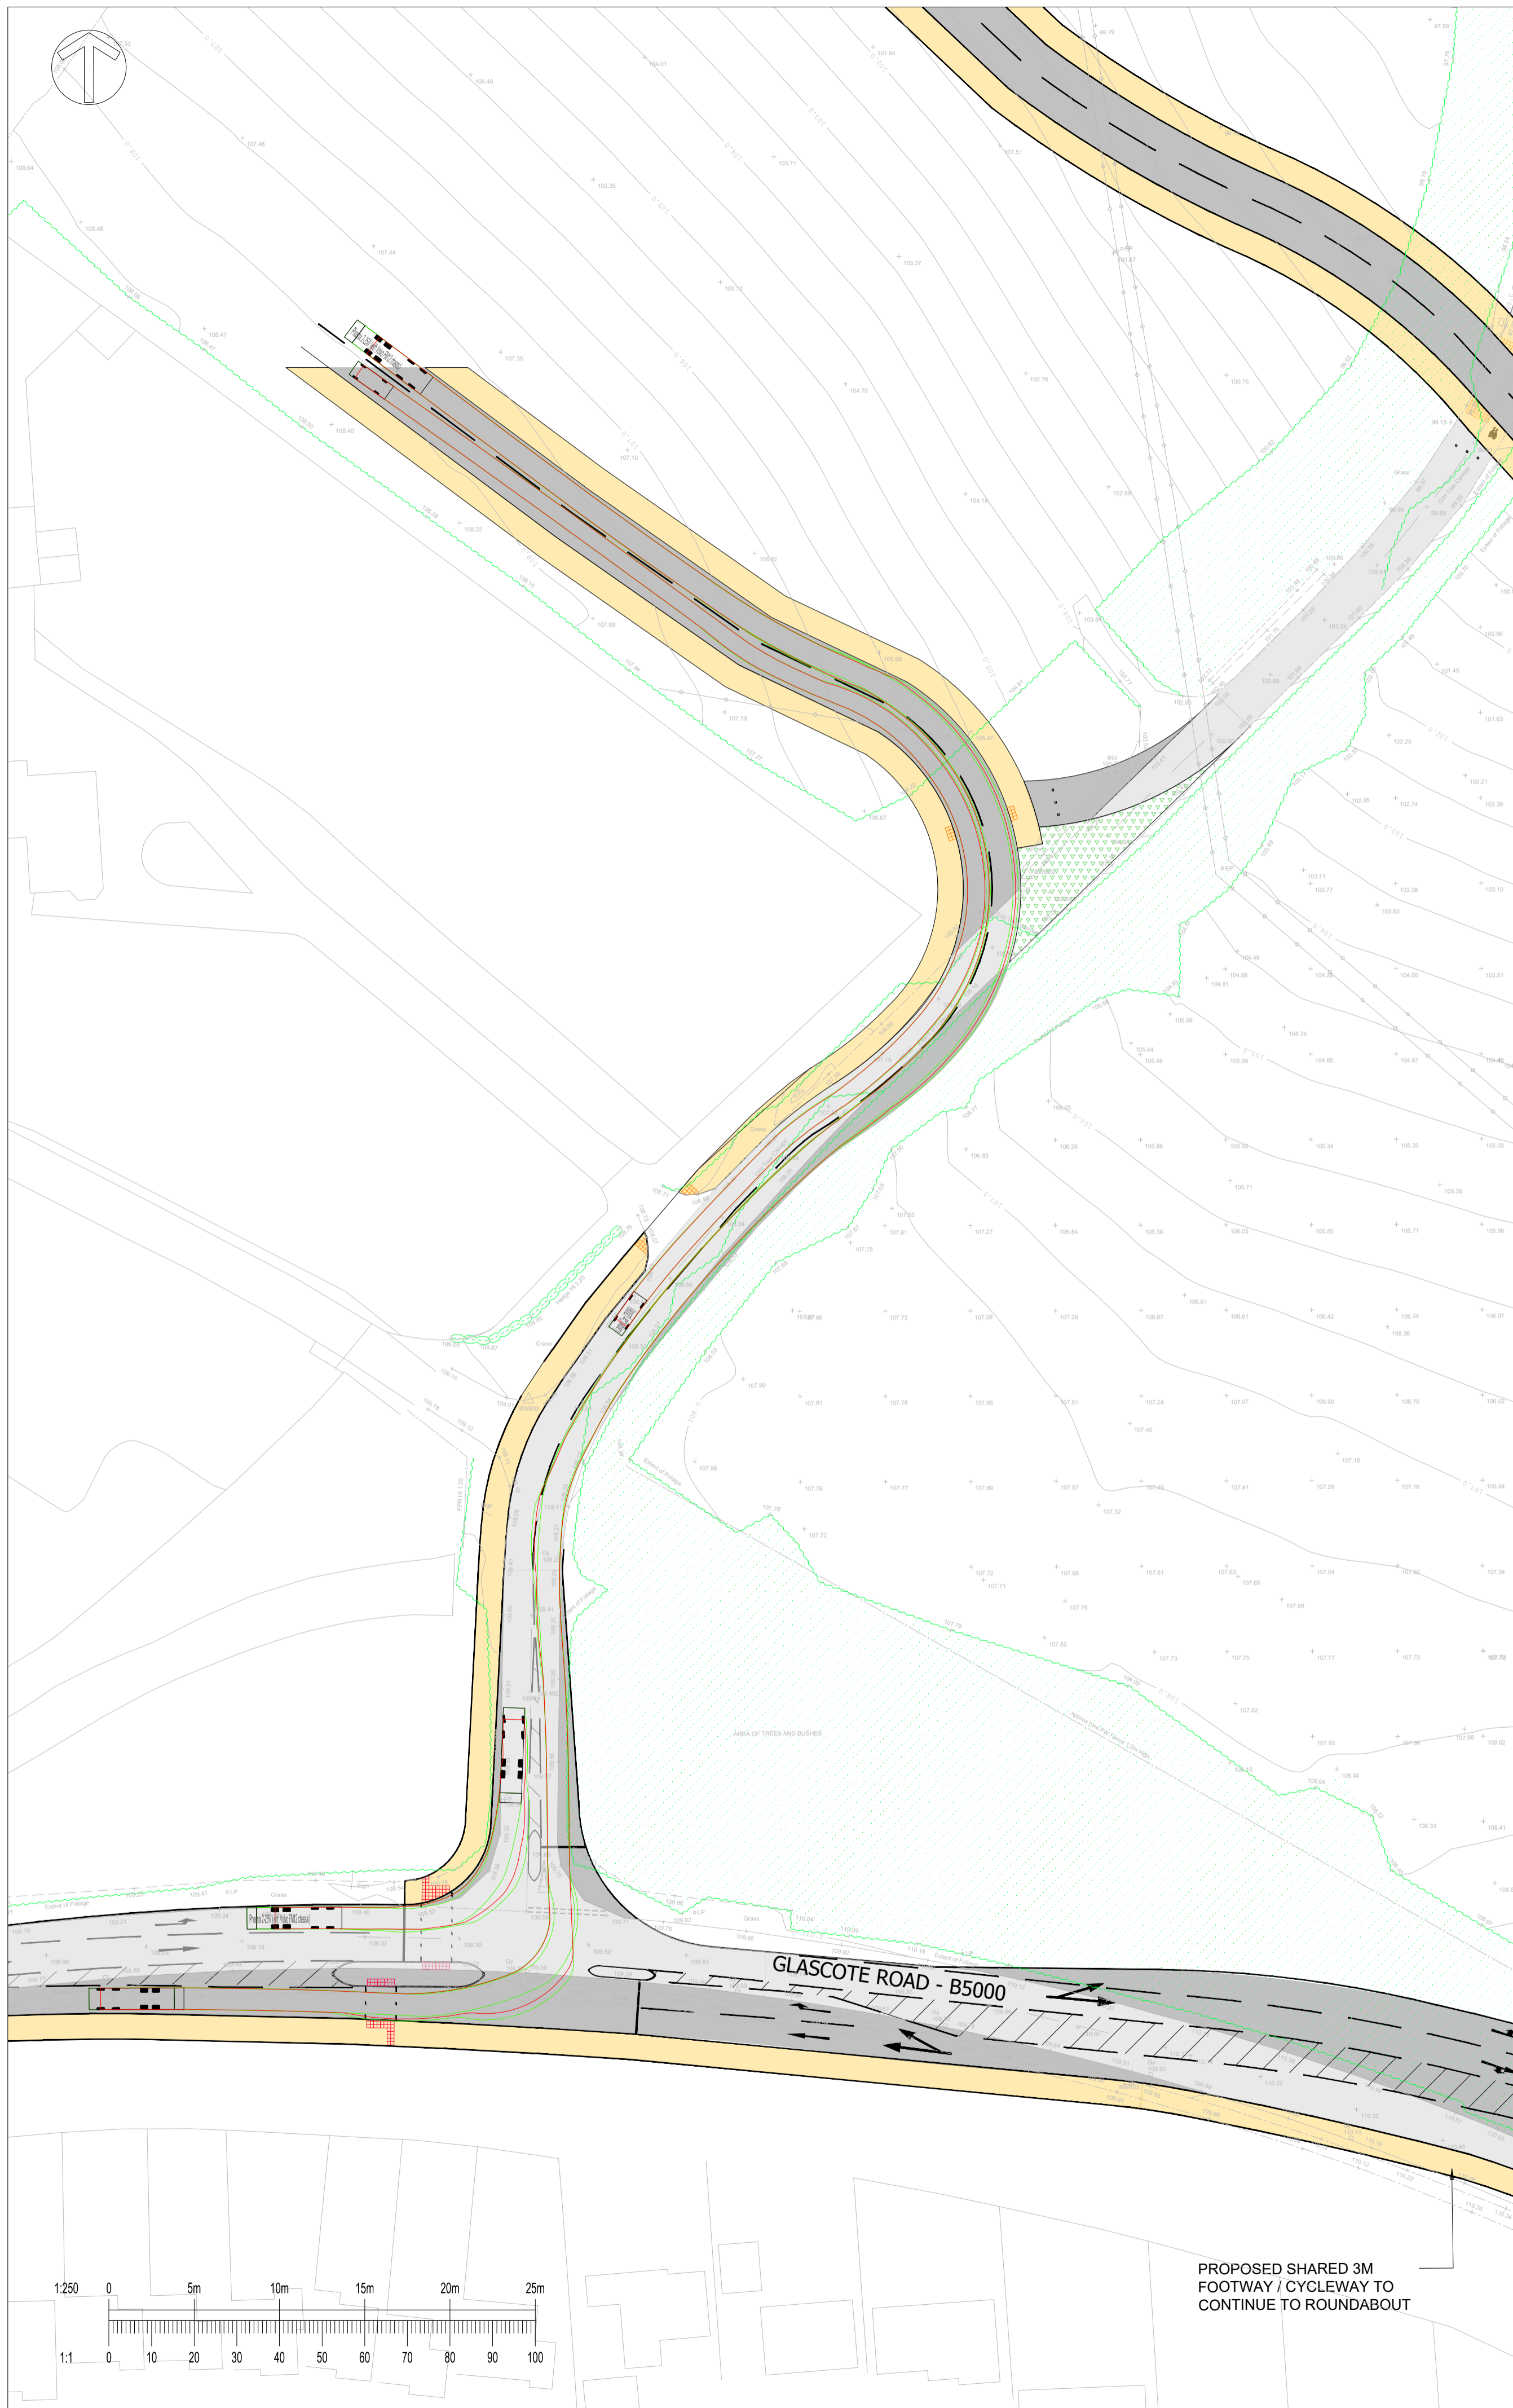
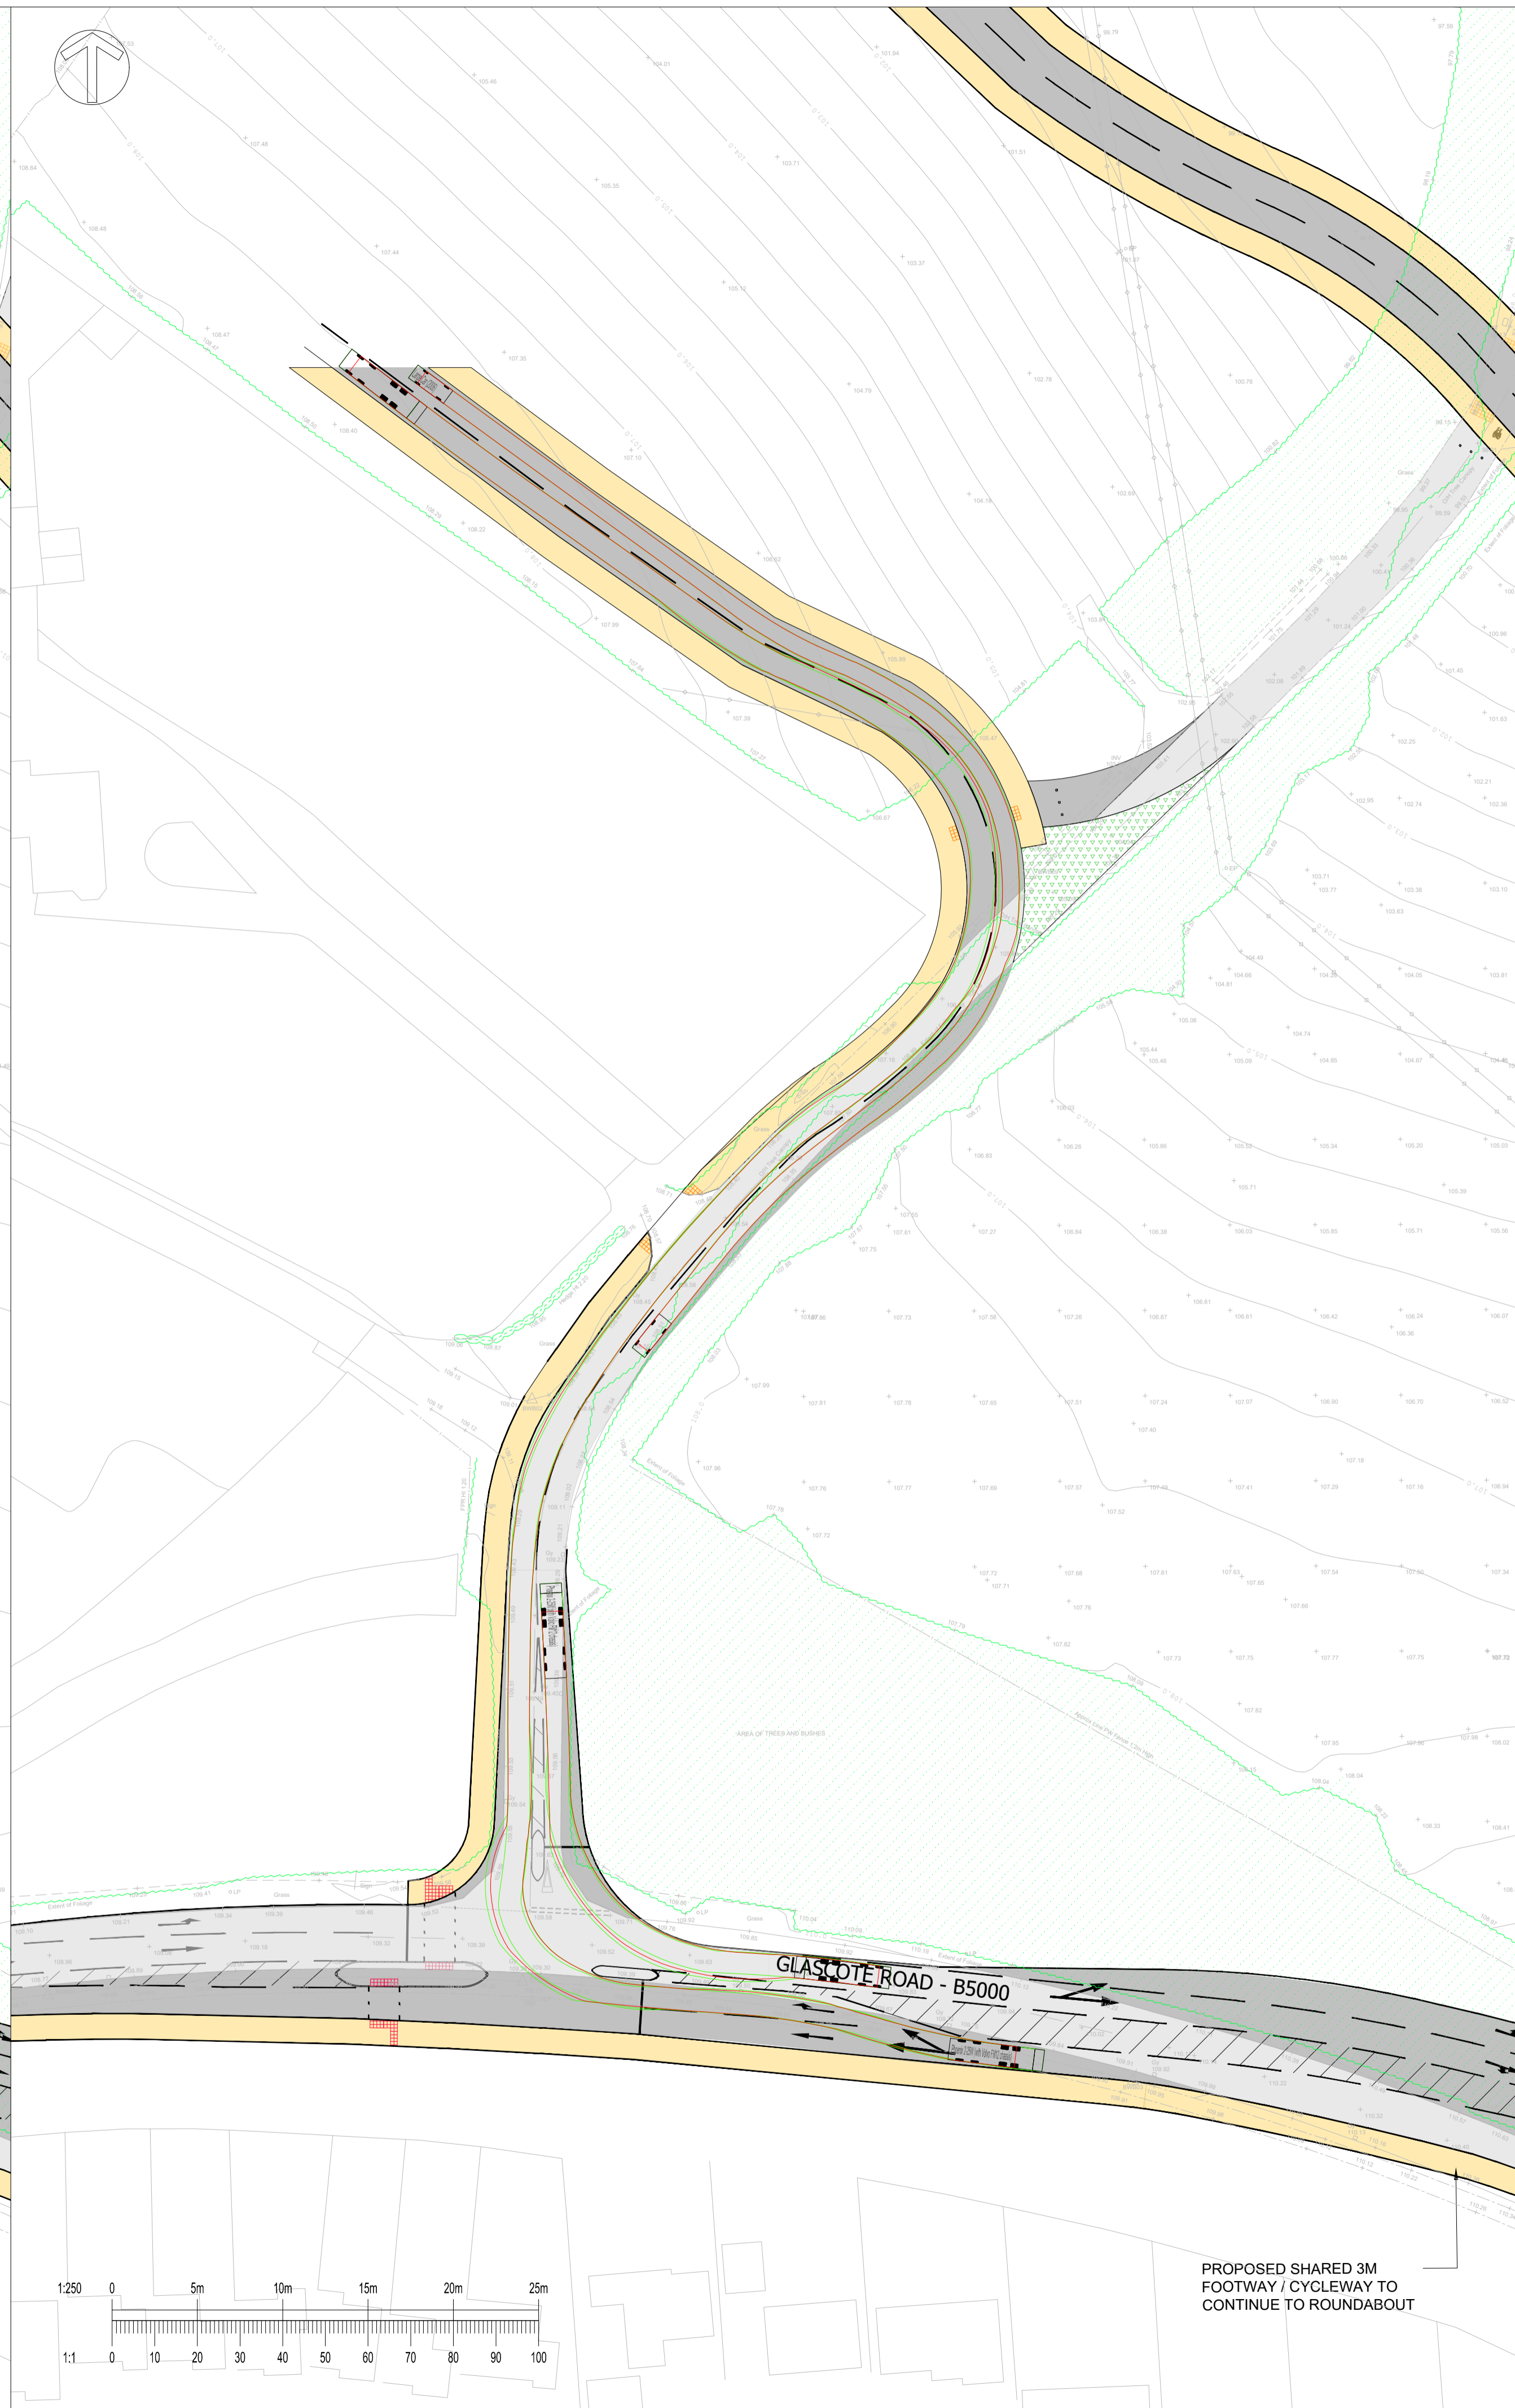
Title
B5000 / ROBEY'S LANE JUNCTION 2 VEHICLE TRACKING SHEET 2

Phoenix 2-25W (with Volvo FM12 chassis)
 Overall Length 11.125m
 Overall Width 2.530m
 Overall Body Height 3.205m
 Min Body Ground Clearance 0.410m
 Track Width 2.500m
 Lock to lock time 4.00s
 Kerb to Kerb Turning Radius 9.250m

Large Car (2006)
 Overall Length 5.079m
 Overall Width 1.872m
 Overall Body Height 1.525m
 Min Body Ground Clearance 0.310m
 Max Track Width 1.831m
 Lock to lock time 4.00s
 Kerb to Kerb Turning Radius 5.900m

PROPOSED SHARED 3M FOOTWAY / CYCLEWAY TO CONTINUE TO ROUNDABOUT

No swept path analysis has been provided to the Audit team. The left turn out of Robey's Lane appears to be tight past the central island. If insufficient it could lead to larger vehicles striking the island and in turn the signal equipment, guard railing or pedestrians on the island.

It is recommended that vehicle swept path analysis is carried out to ensure vehicles can make all manoeuvres at the proposed junction.
