PROJECT NAME:
 Nailcote Farm

PROJECT
 Fillingley Solar

TITLE			
Section Views			
NUMBER	REVISION		
P.NailcoteFarm_06_SectionViews	B		
SCALE (A3)	SHEET	DRAWN	APPROVED
1:50	1 OF 2	AMS	CC

Enviromena Project Management UK Limited
Nailcote Farm
Warwickshire
Drainage Strategy

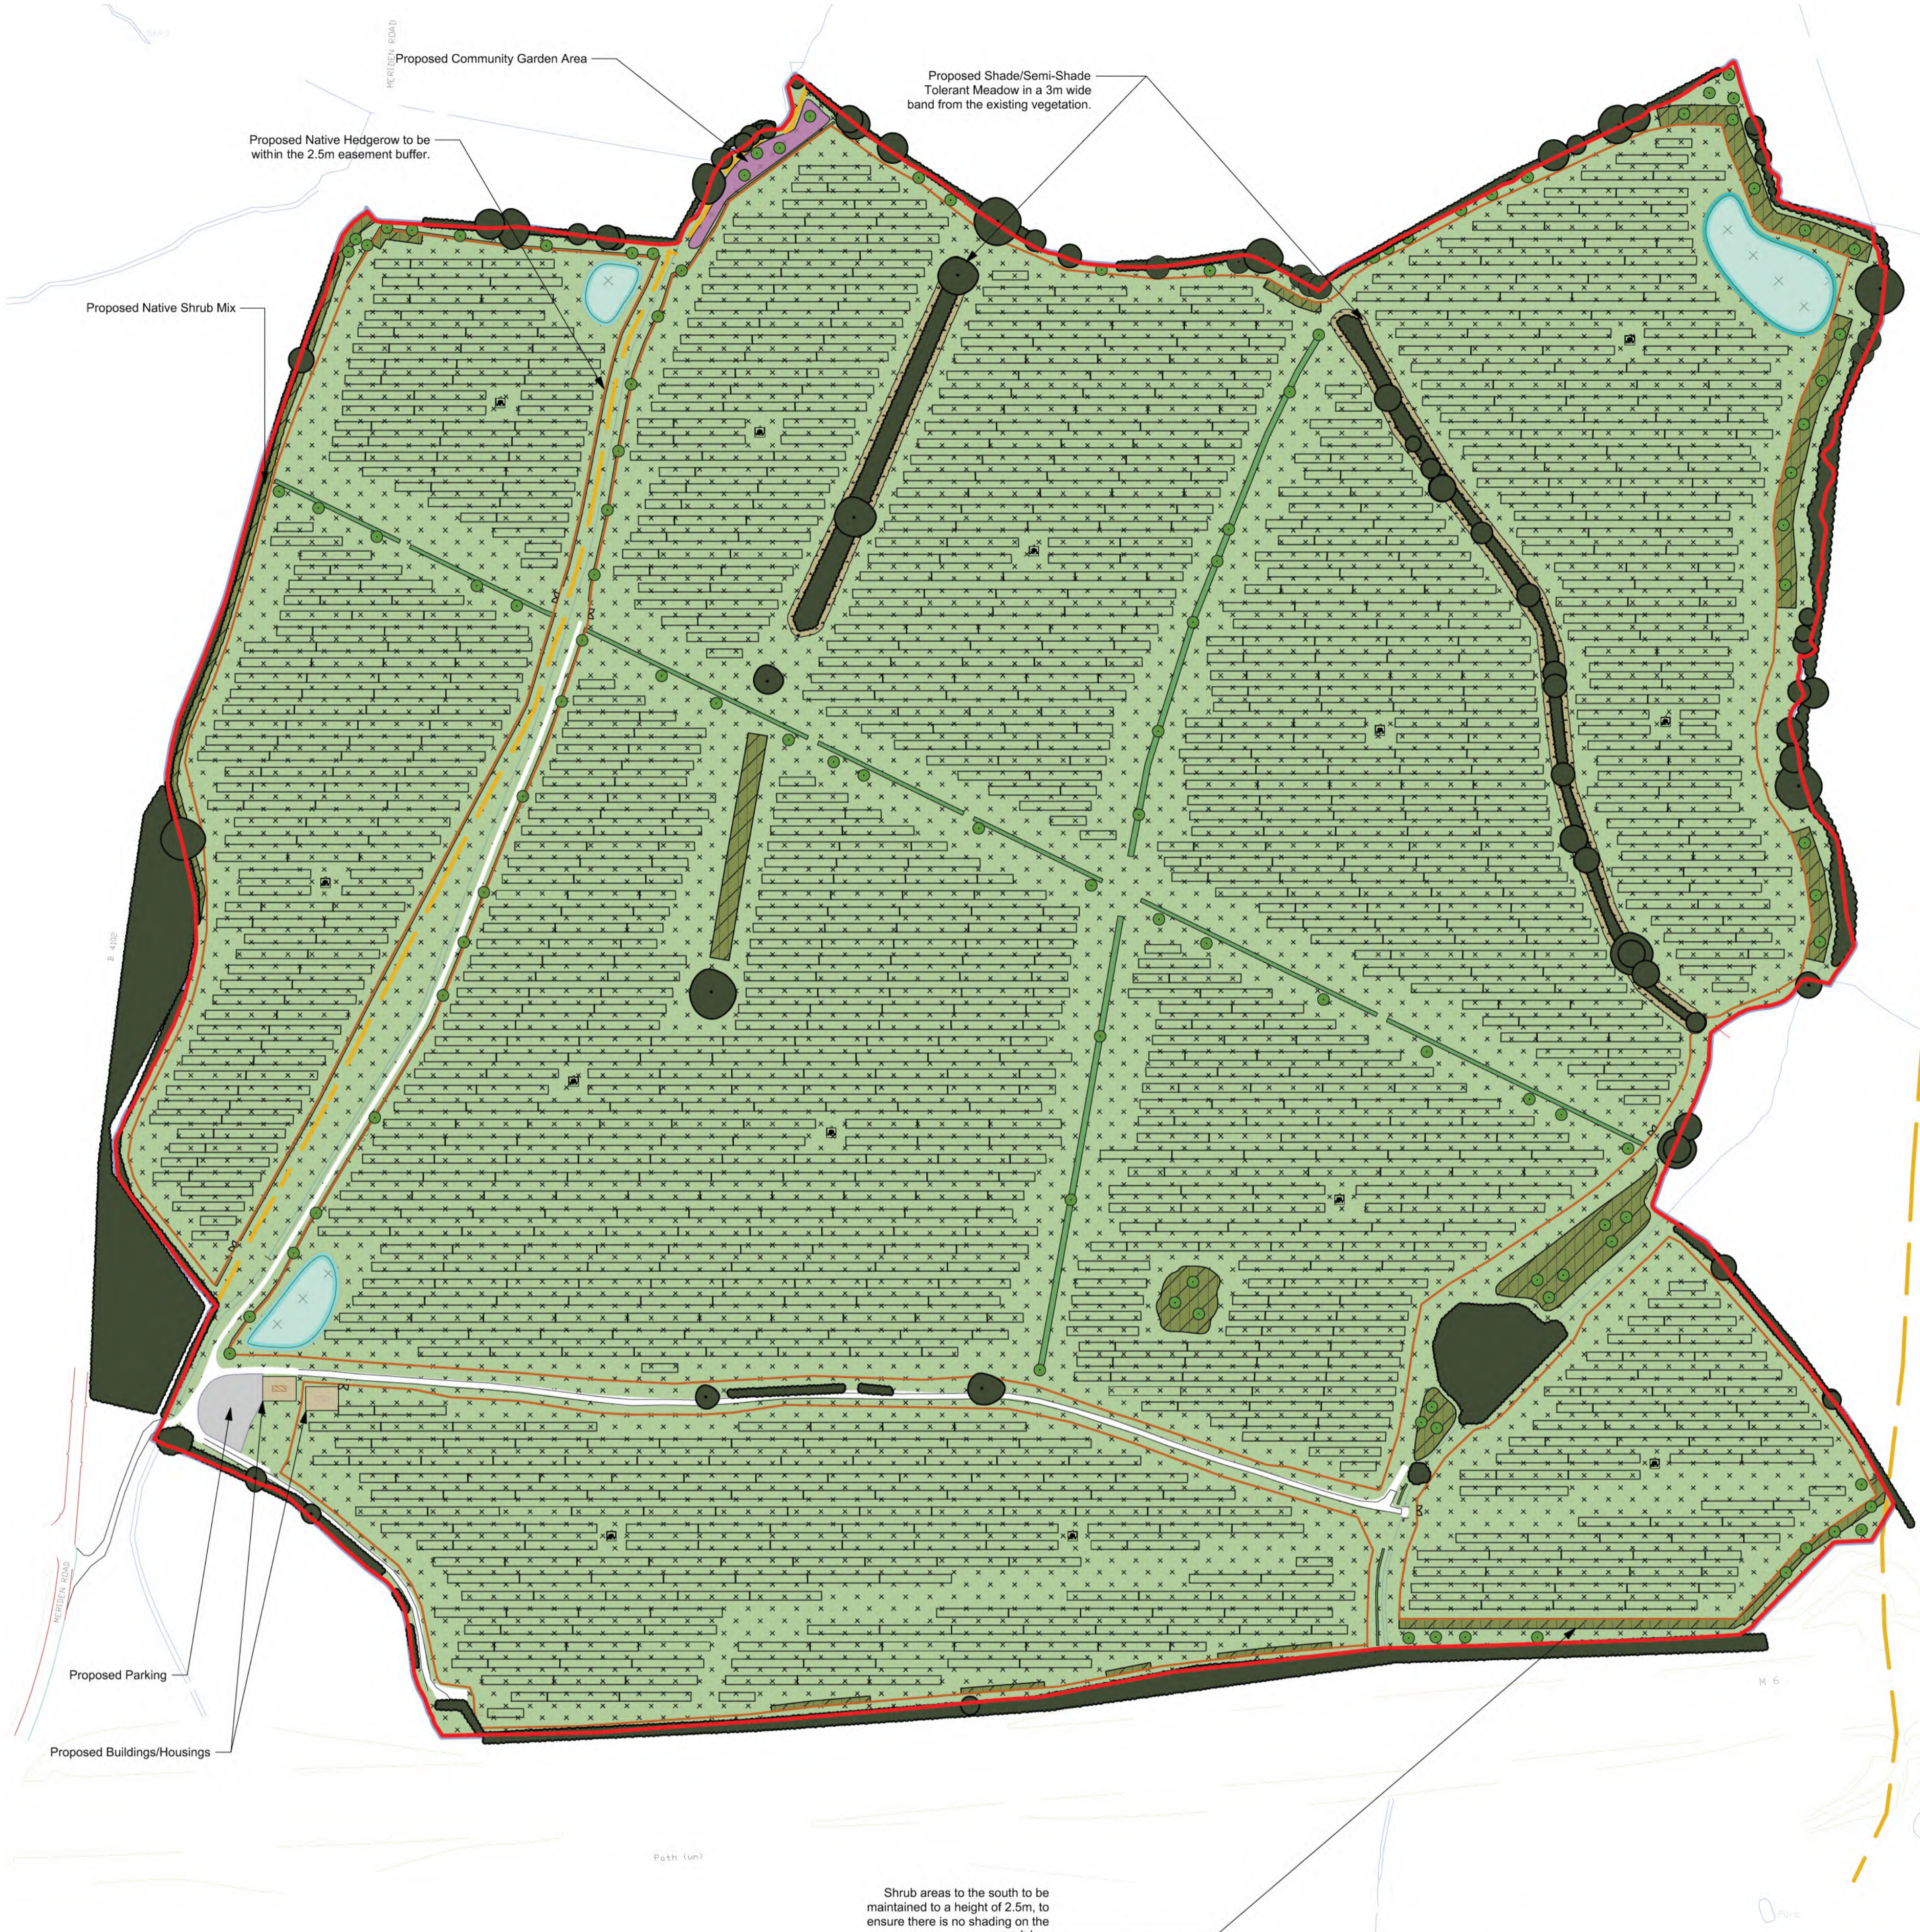
Proposed Landscape Mitigation

Species listed below consider site constraints and meet the required landscape and managements strategies outlined in the relevant landscape character study. This is only an indicative list of potential species that could be used on the site.

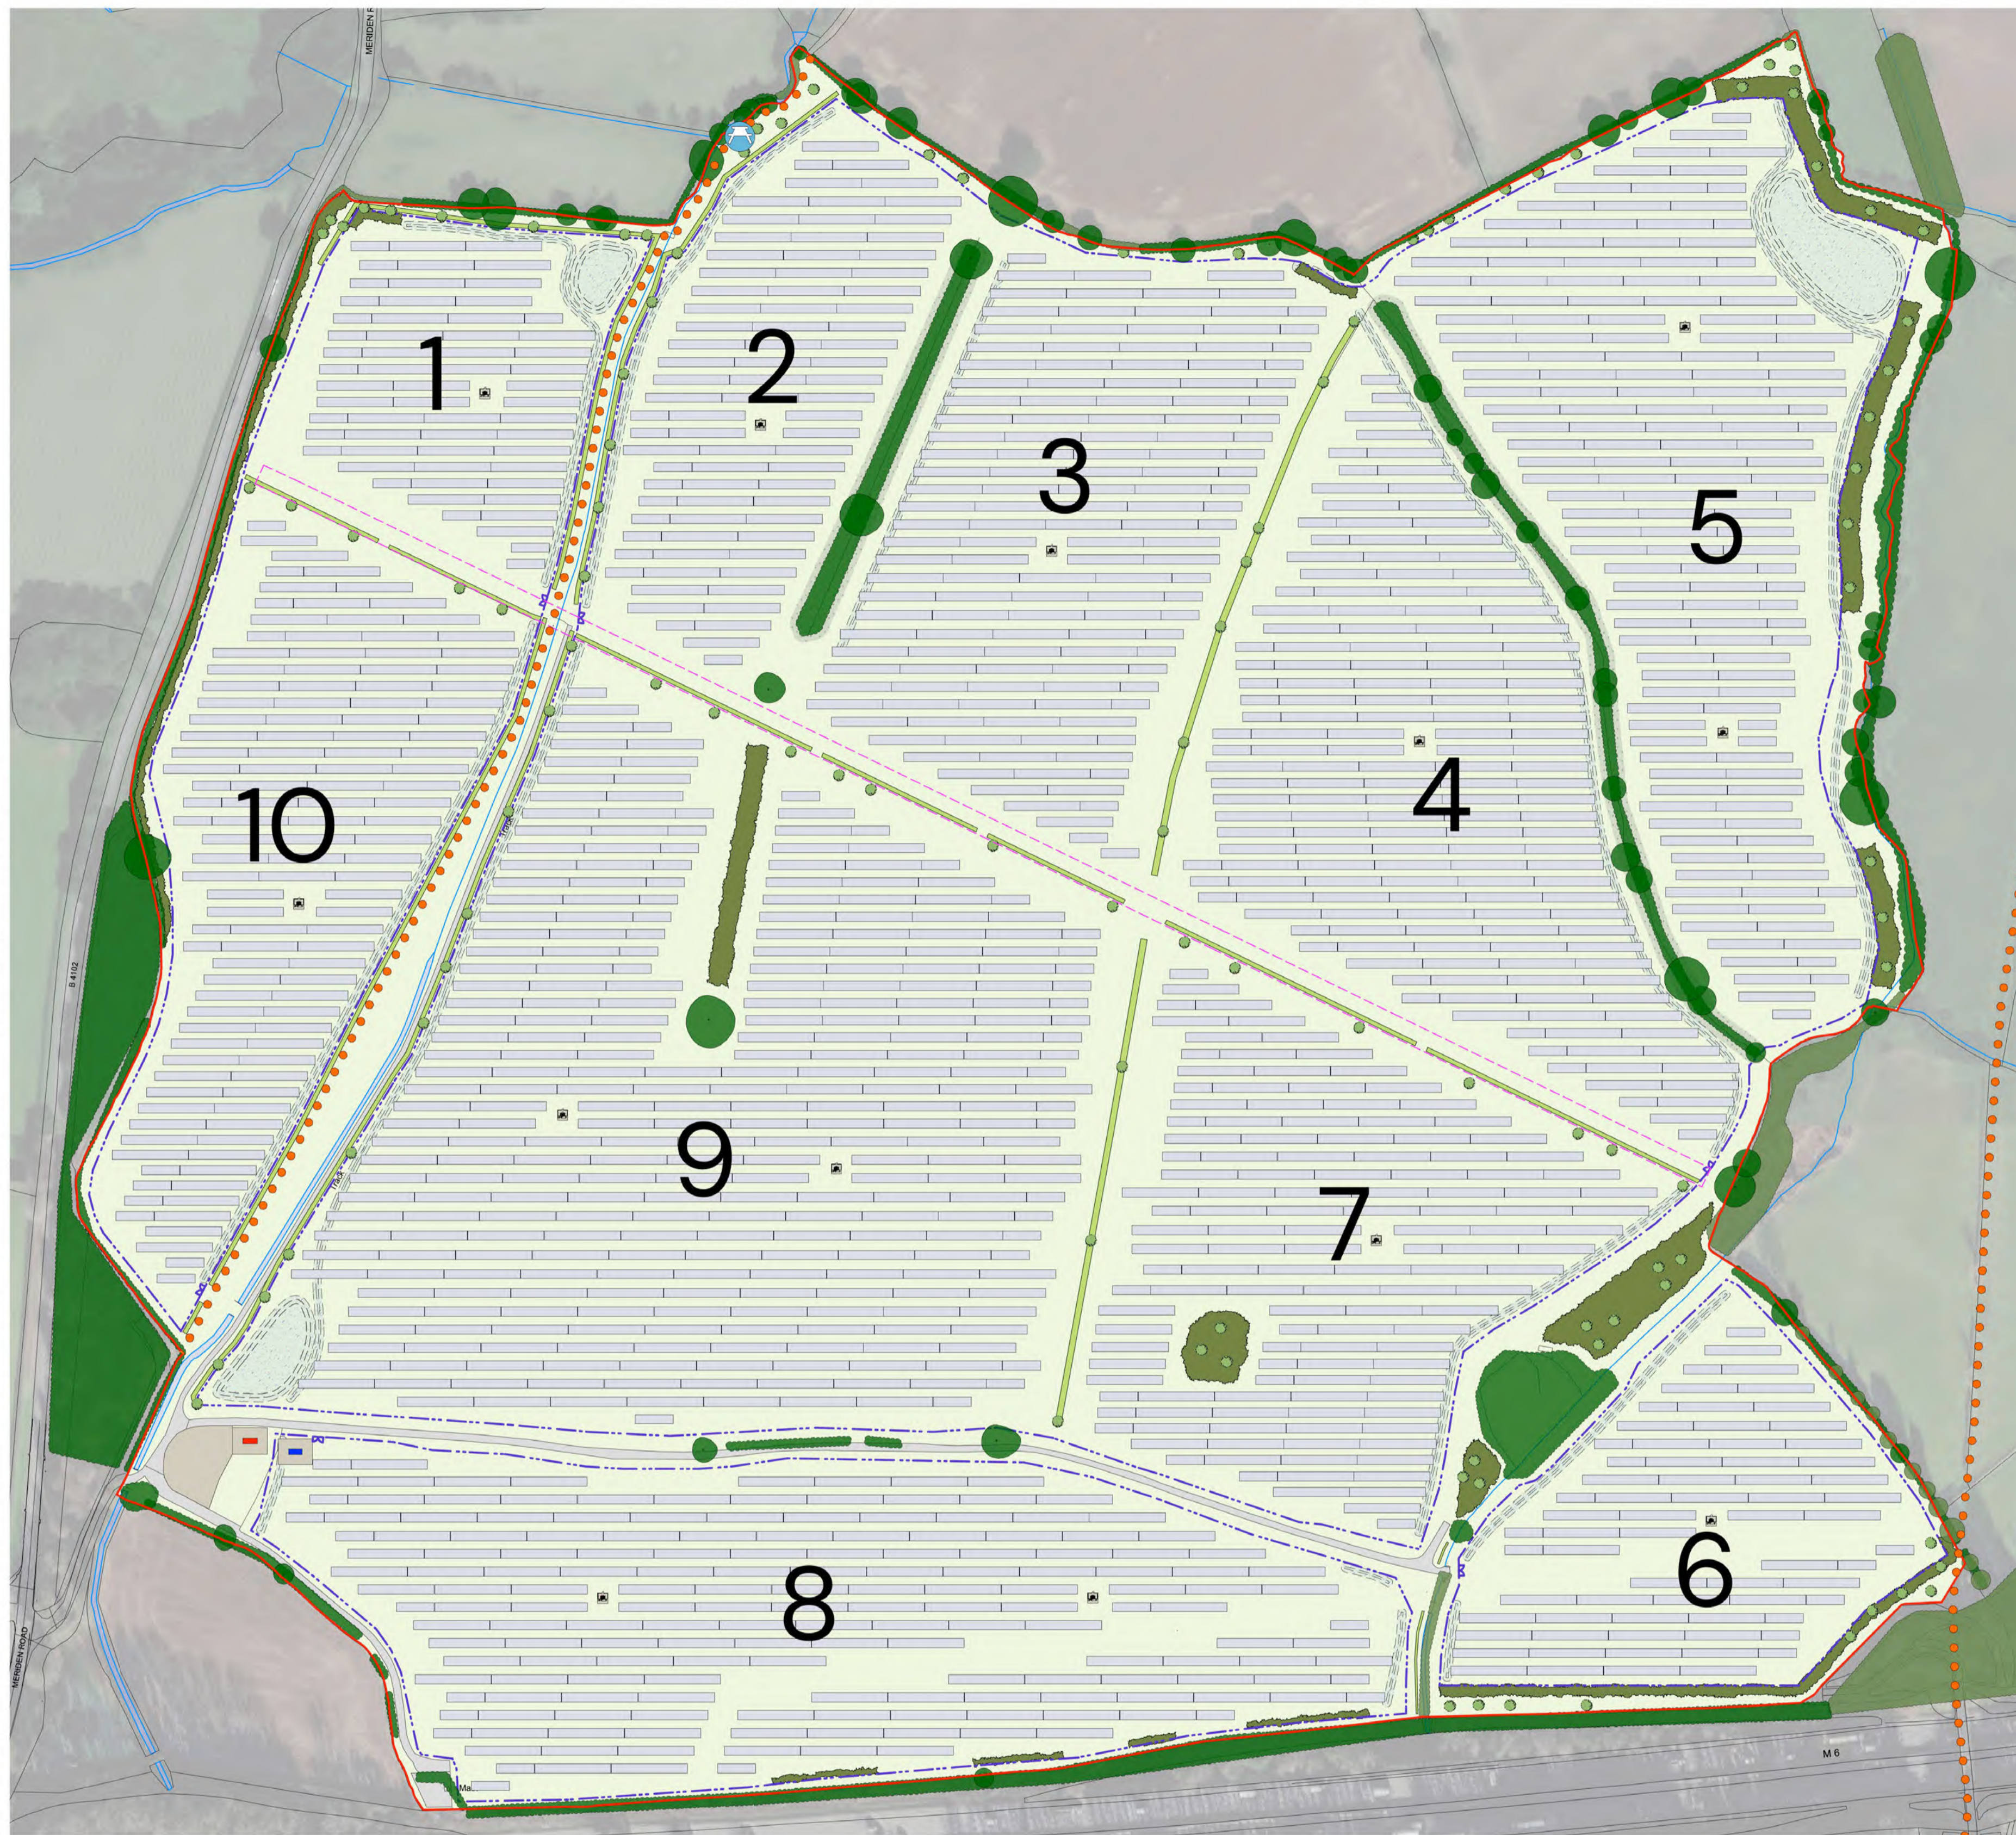
Proposed Landscape Mitigation

Species listed below consider site constraints and meet the required landscape and management strategies outlined in the relevant landscape character study. This is only an indicative list of potential species that could be used on the site.

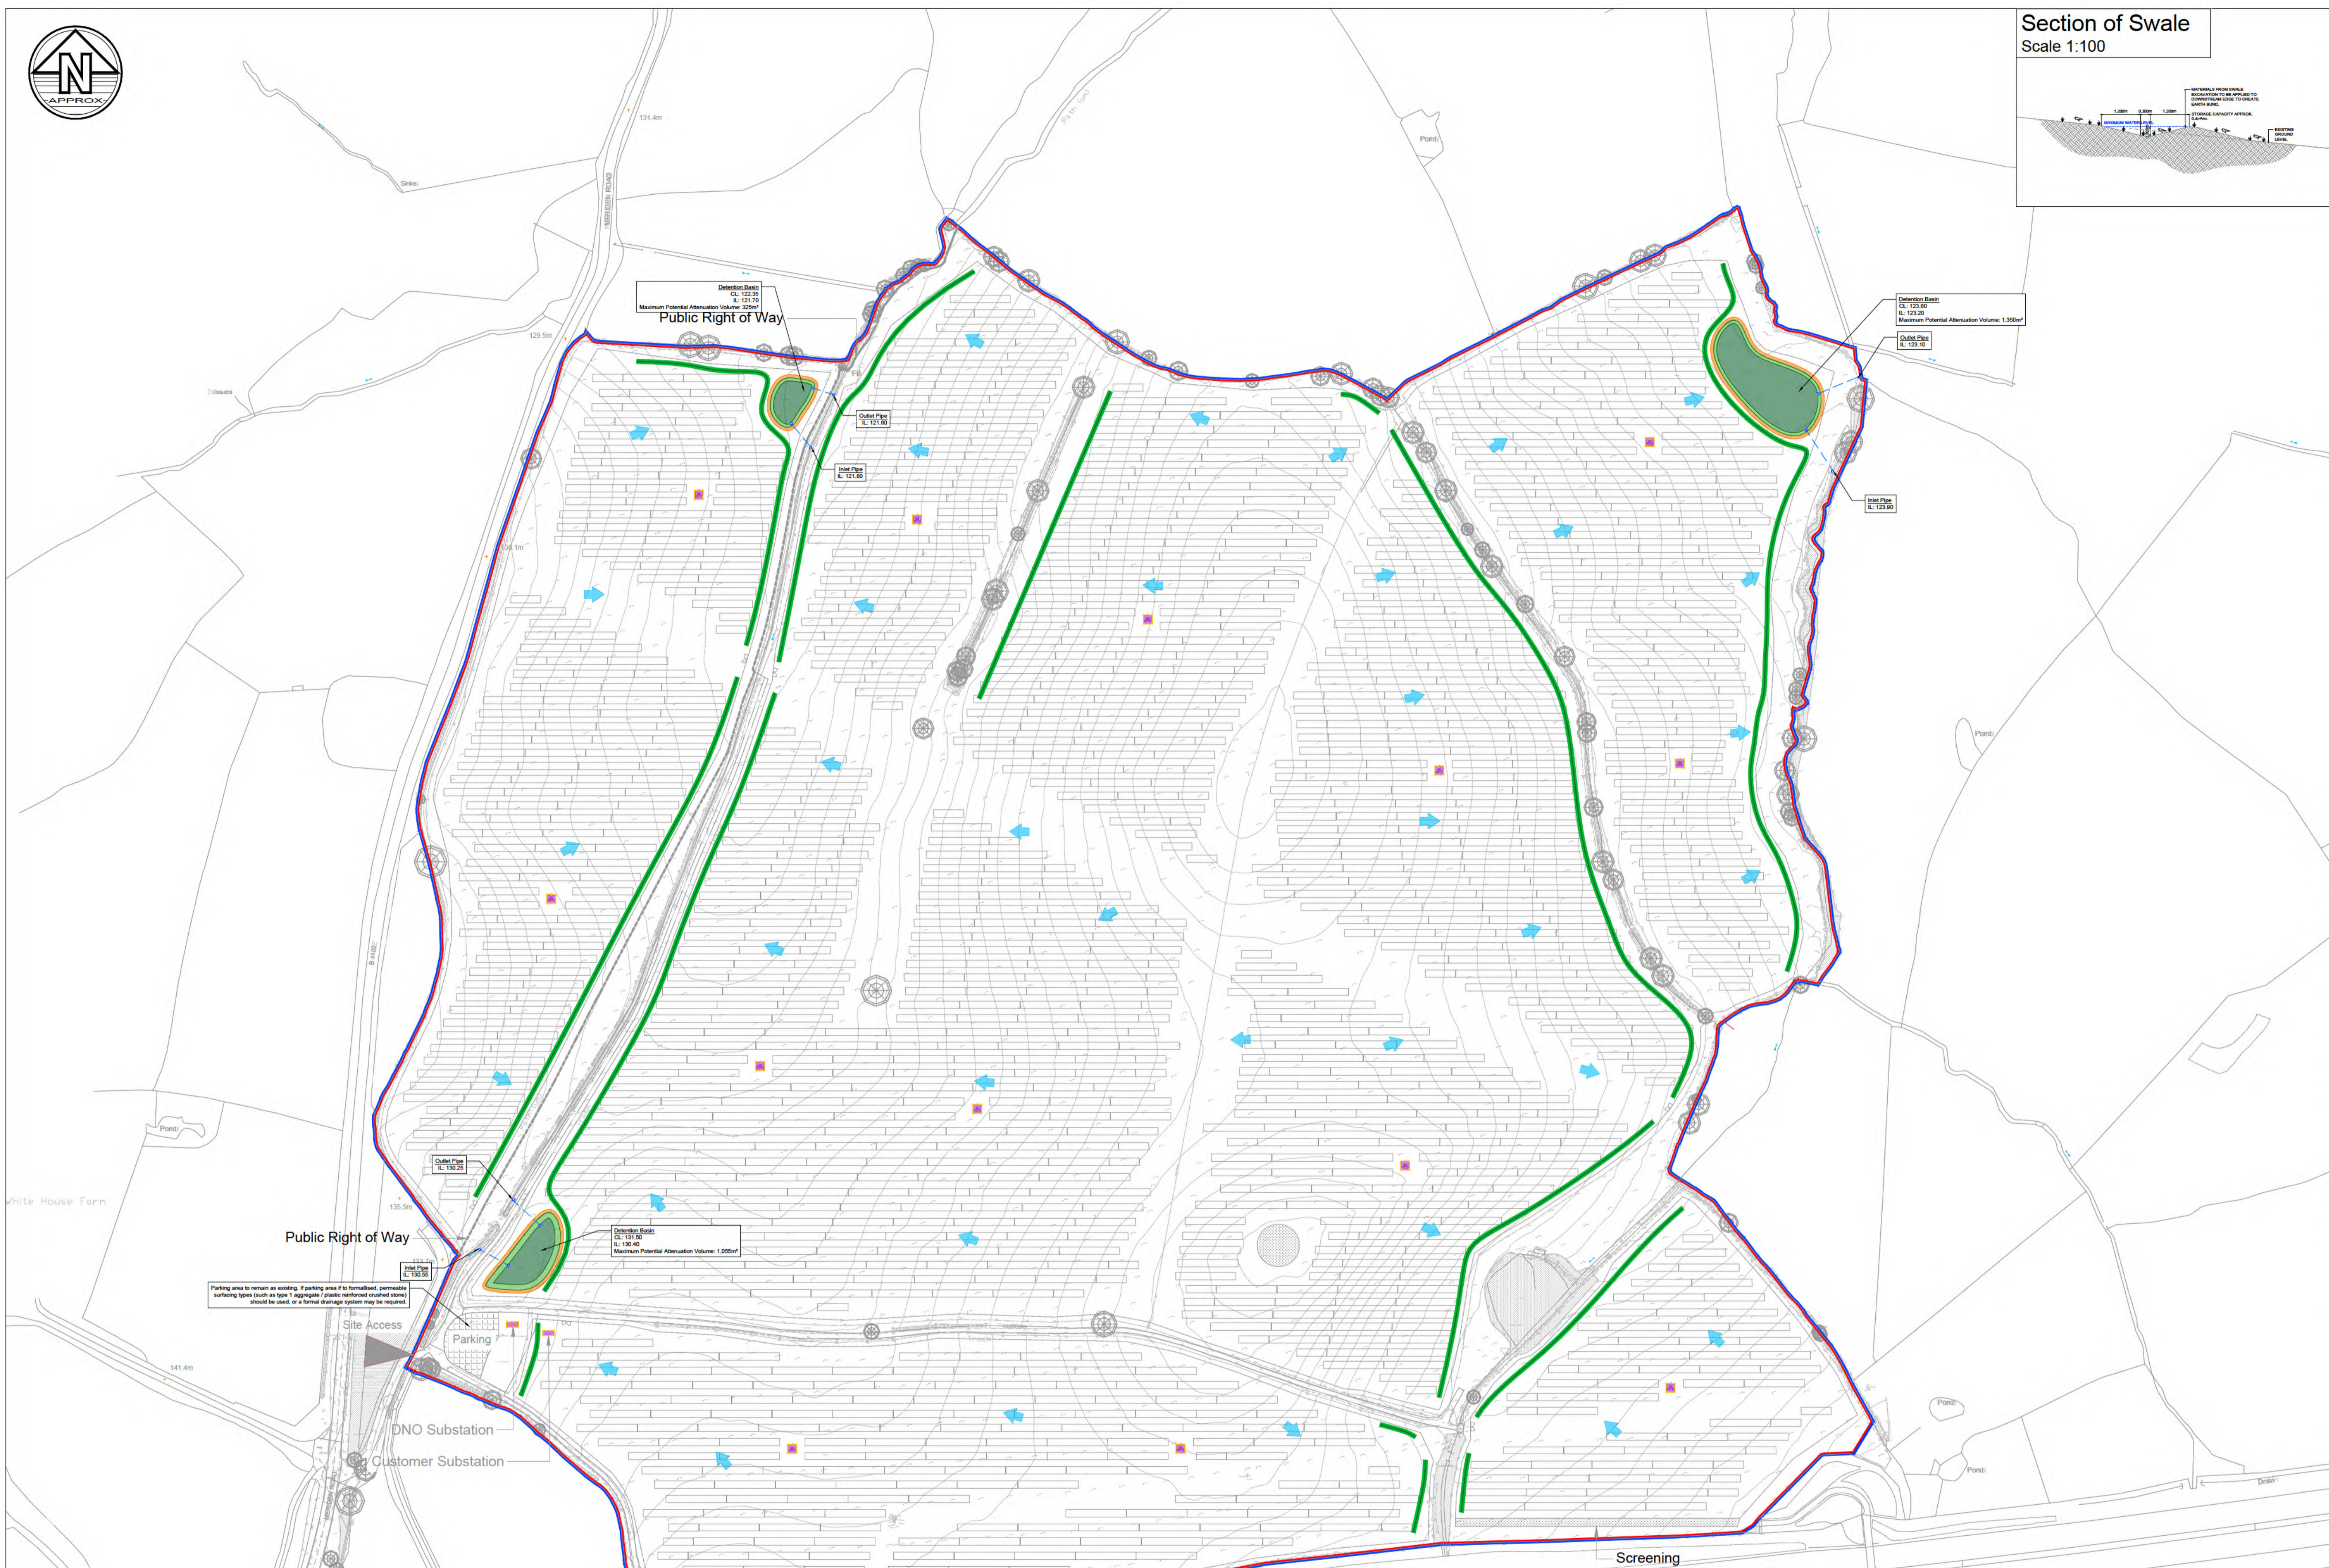
- This report should be read in conjunction with BWB Consulting Drainage Strategy 'NFW-BWB-ZZ-XX-RP-CD-0001' and drawing 'NFW-BWB-ZZ-XX-CD-0002'.
 - Detention basin details to be confirmed as part of the tender / discharge of conditions design stage.

- Site Boundary
- Measured Impermeable Area
- Swales
- Indicative Infiltration Trench
- General Direction of Overland Flow
- Detention Basin with Maintenance Walkway
- Inlet / Outlet Pipe and Headwall

Measured Impermeable Area: 362m² (0.04ha)

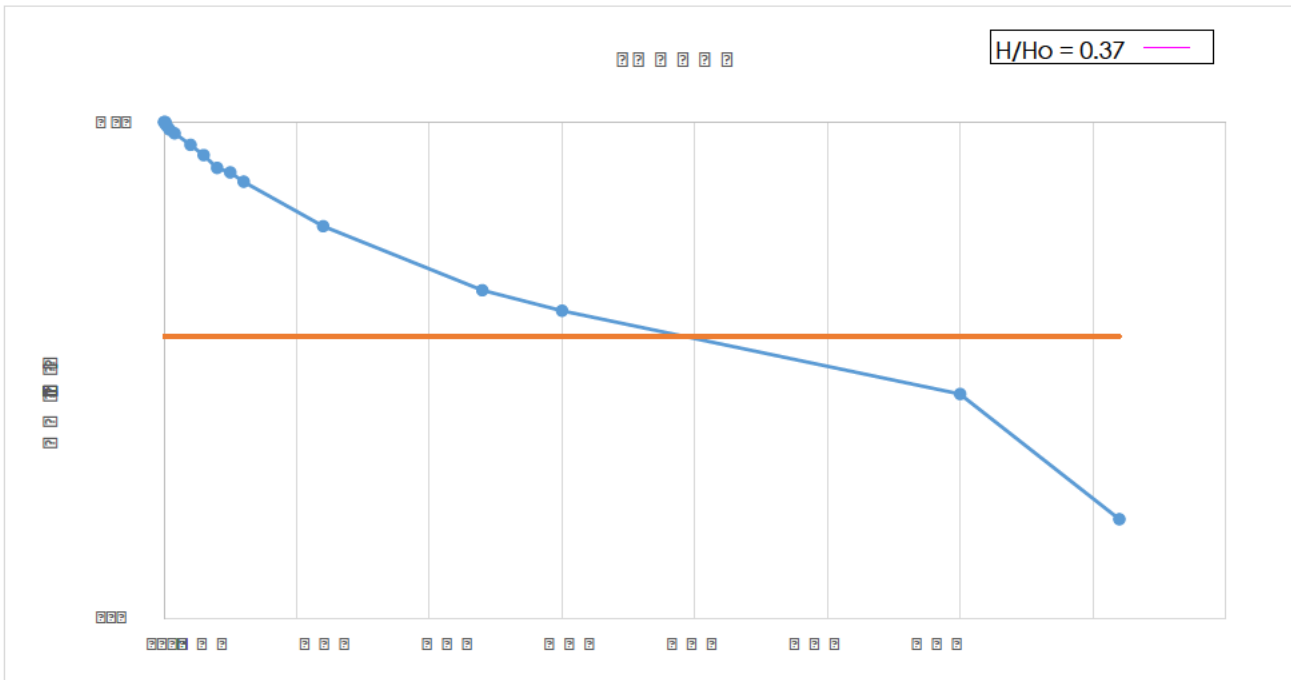
Project Name:	Nailcote Farm
Project Number:	221748
Borehole Ref:	FH06
Date:	14-Sep-23
Borehole Diameter (mm):	60
Resting Water Level (m bd):	1.20
Length (L) of Response Zone (m):	1.00

K = 1.37E-07 (m/s)
K = 0.012 (m/d)

Groundwater was not encountered during the drilling, however it was observed in FH06 prior to the commencement of the permeability testing. The level was recorded at 1.20m bgl on the first day of testing, and 0.90m bgl on the second day.
